Asbestos in The Building Trades -Hidden Hazards-

Dave Garrett, CIH

Senior Occupational Hygienist,
WorkSafeBC

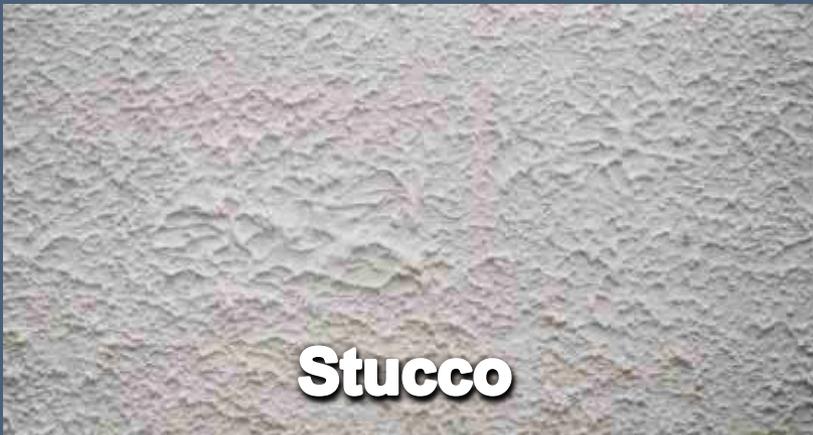
Stucco

- Exteriors
 - asbestos cement materials
 - felts and mastics
 - stucco
 - brick and mortar
 - insulation

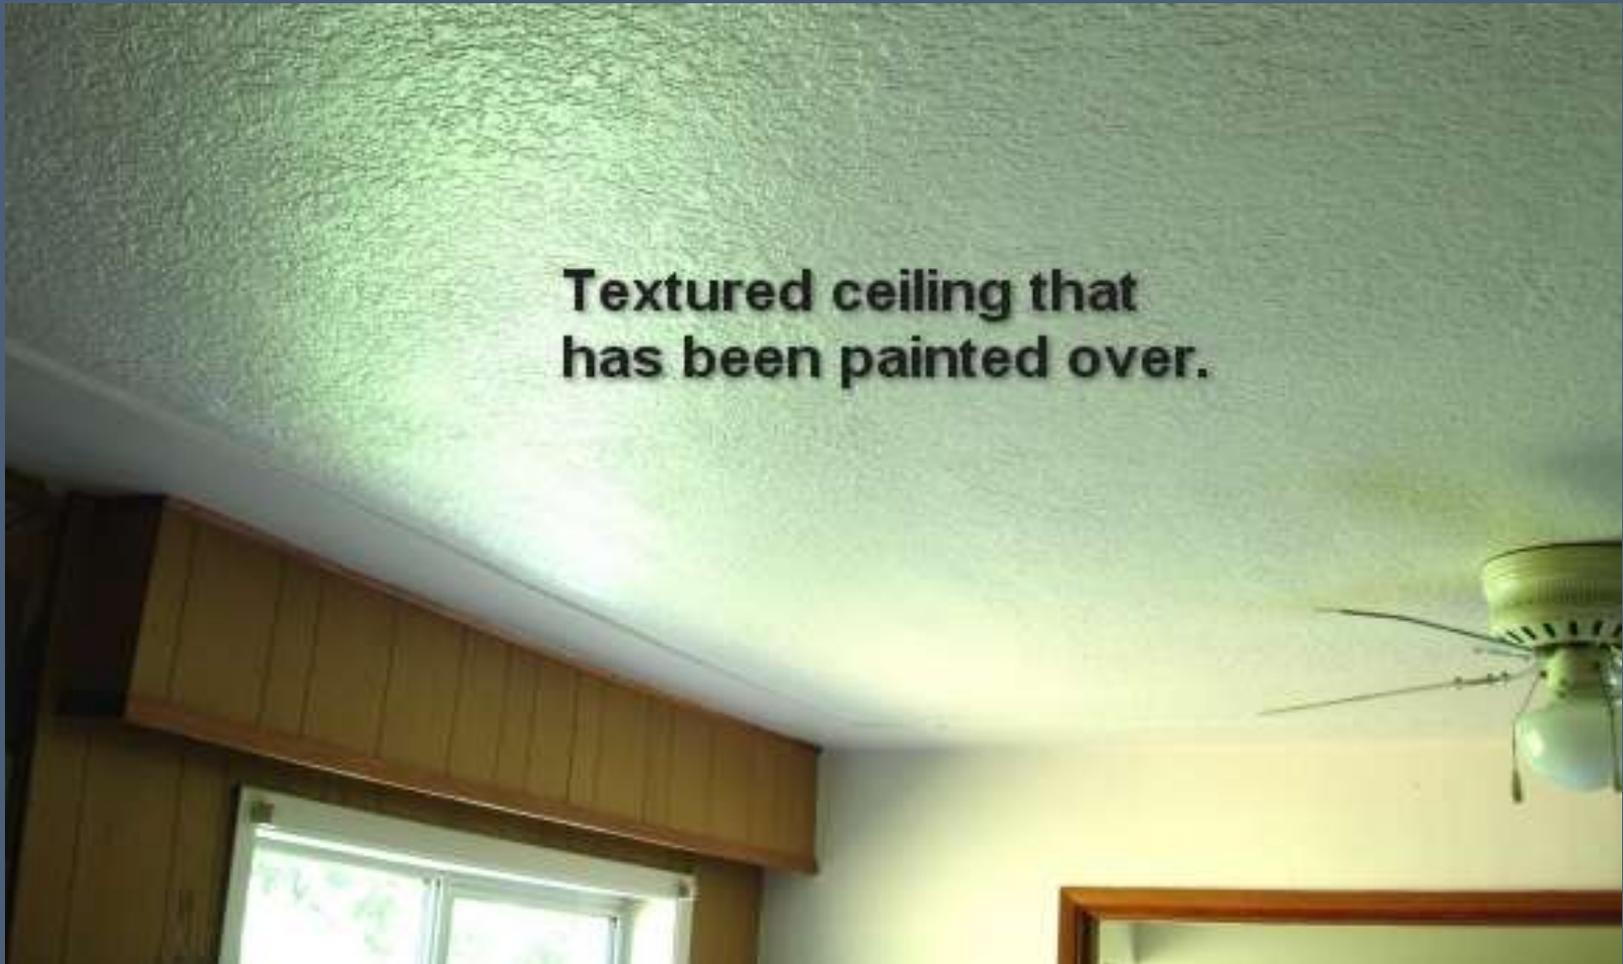
**Textured ceiling that
has been painted over.**

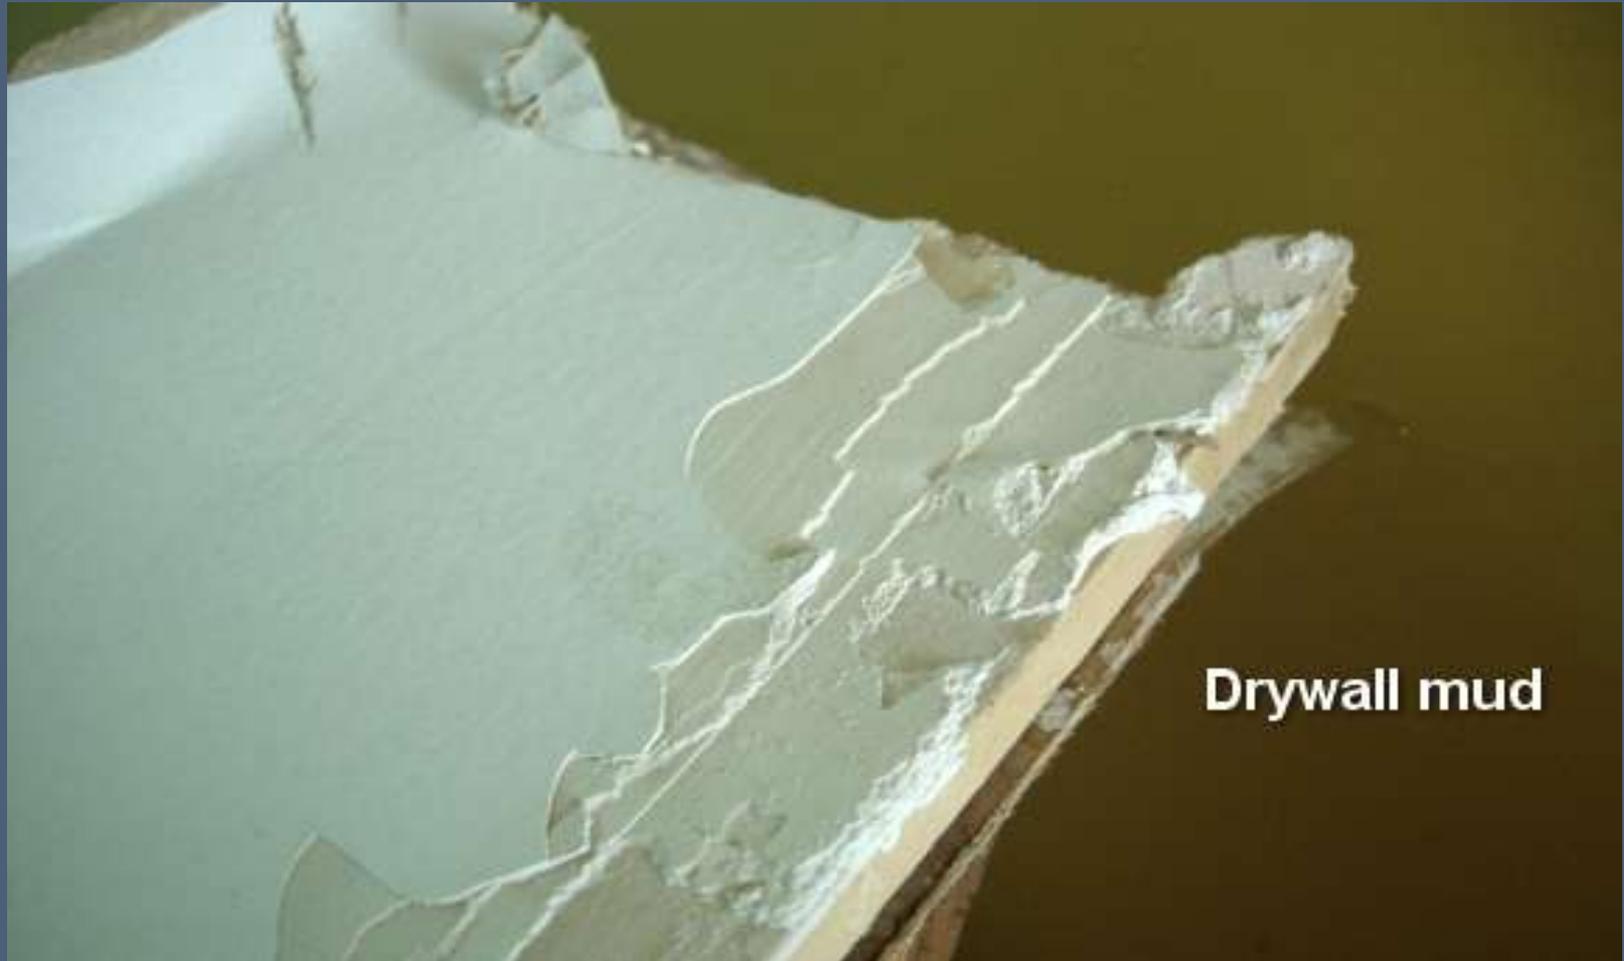
Drywall mud

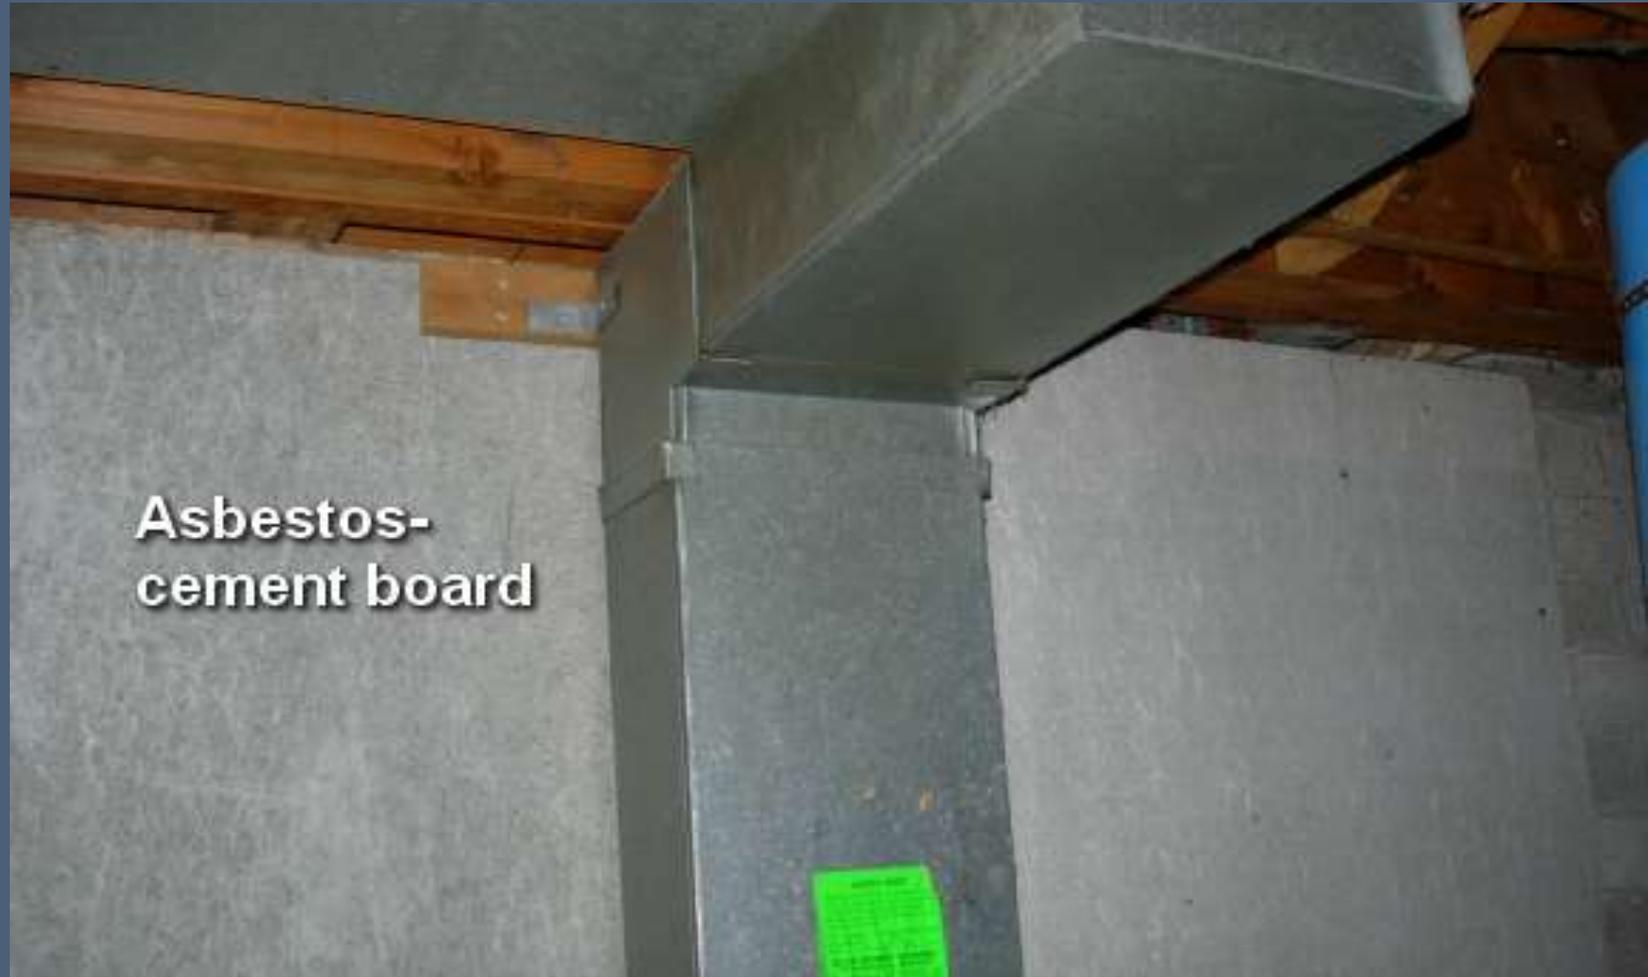
Asbestos-
cement board

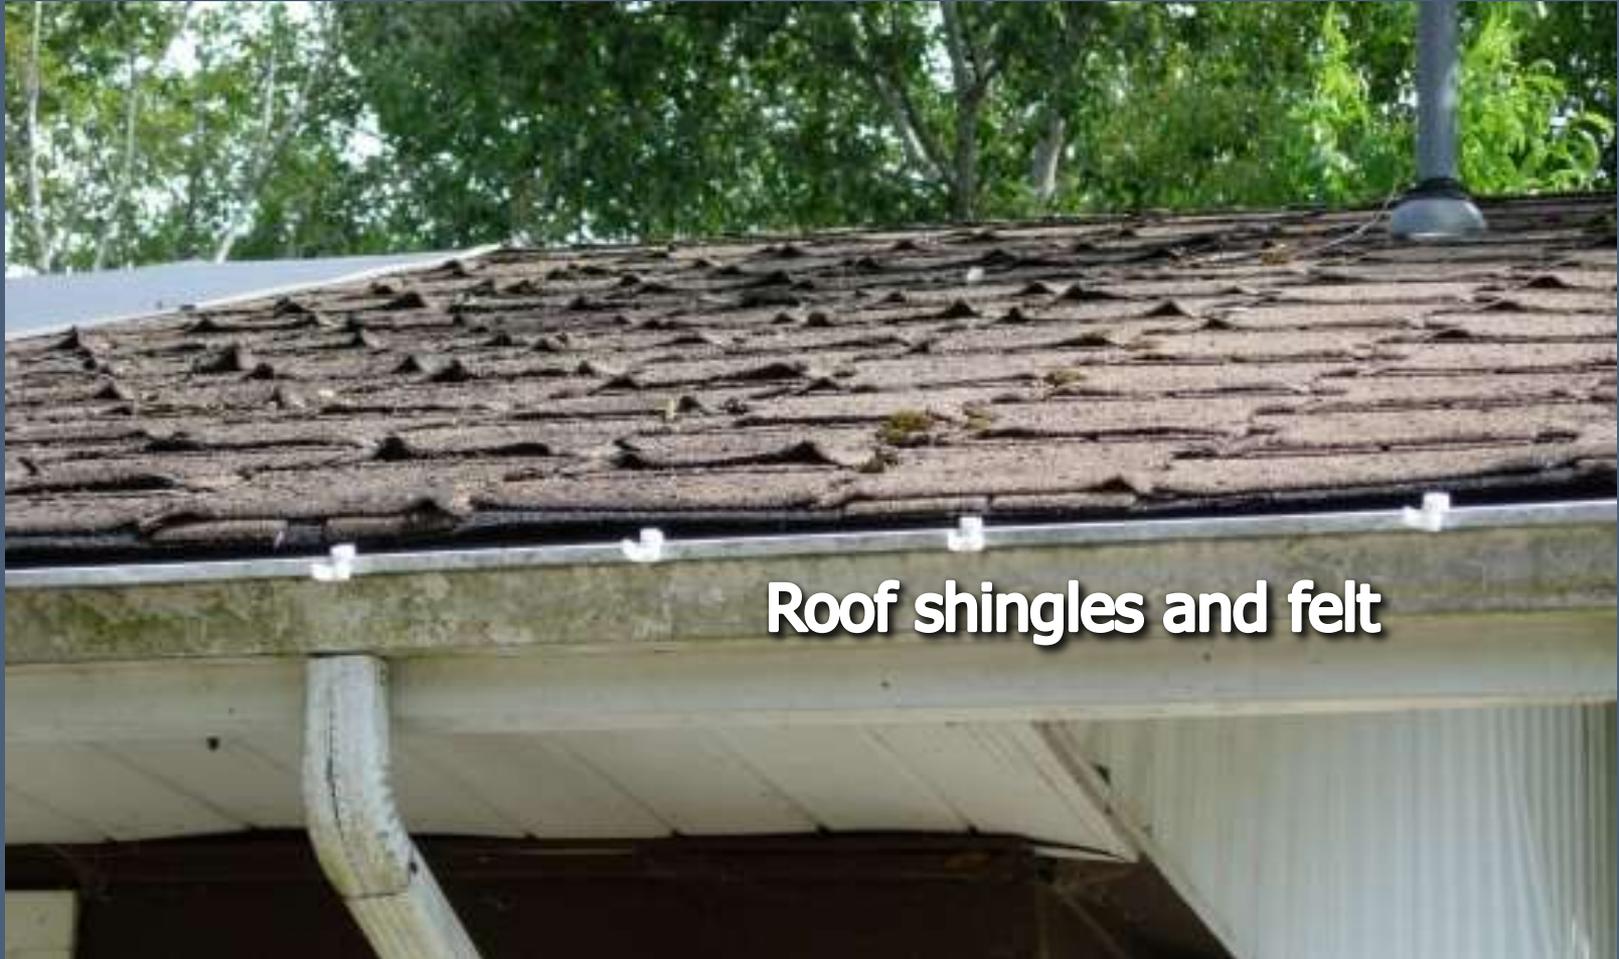
Roof shingles and felt

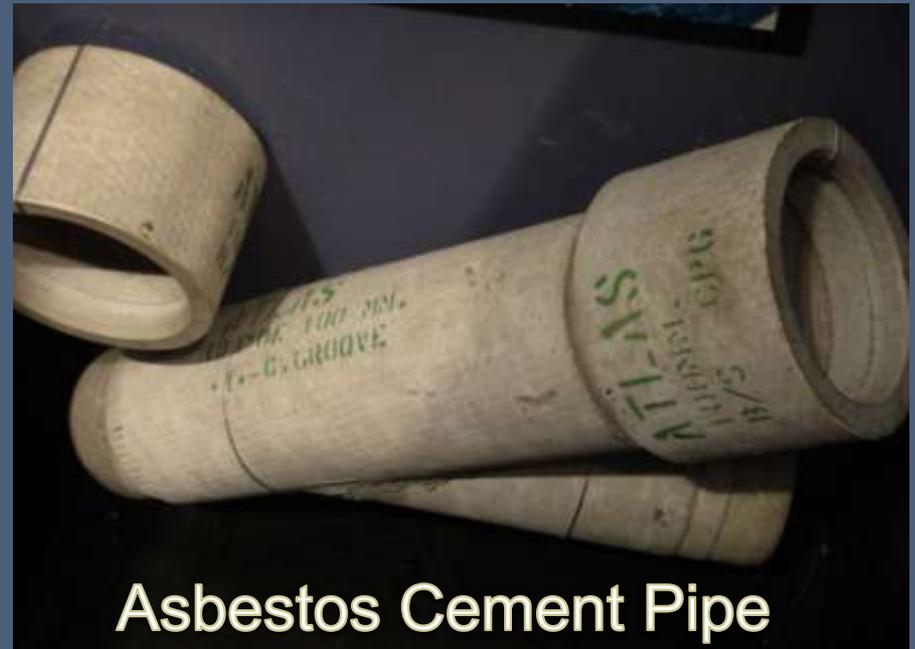
Asbestos Cement Pipe

- Pipe insulation
- Insulating blocks
- Sprayed insulation
- Condensation control
- Roof shingles
- Asbestos cement board and pipe (Transite)
- Caulking compounds

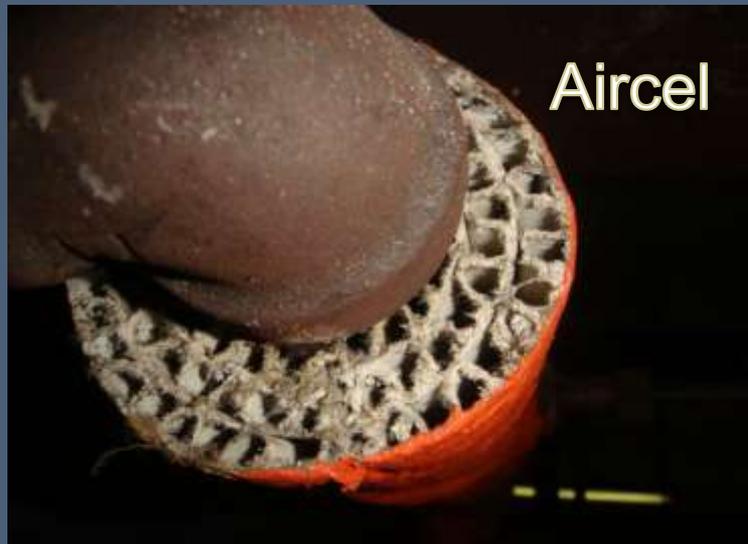
Pipe or Boiler Insulation

- Asbestos-containing material (ACM) was often used as thermal mechanical insulation.
- Can be pre-formed insulation sections, blocks or mudding compounds.
- Often used with fiberglass insulation.

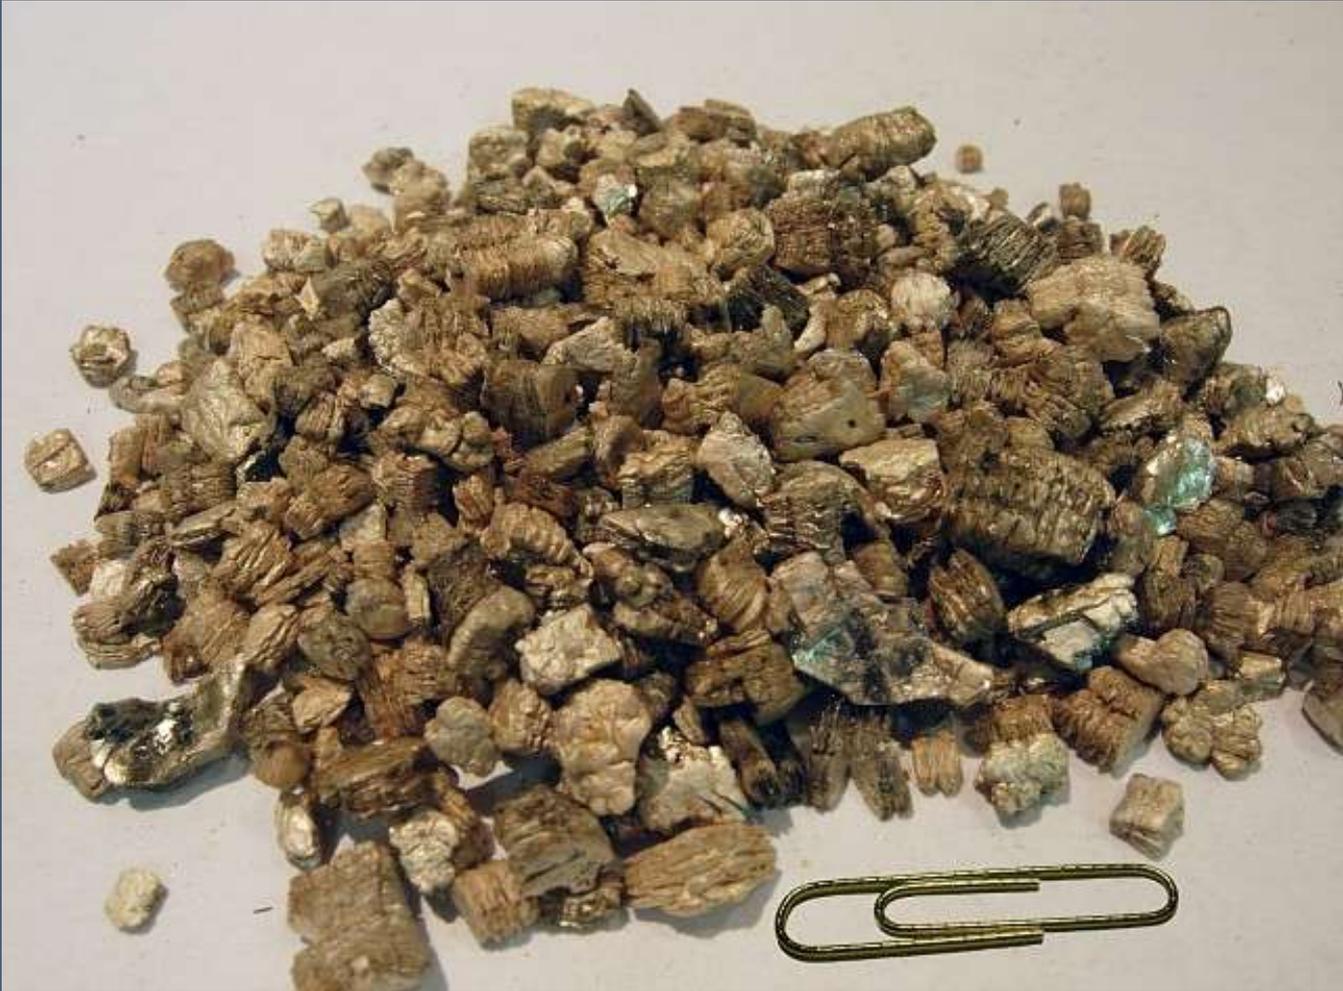
What is Vermiculite?

- Vermiculite is a mica-like mineral that was used as insulation in many houses and commercial buildings between 1920 and the late 1980's.
- When heated, it expands like “popcorn” into a loose, lightweight material that is absorbent, fireproof, and a good insulator.
- Much of this vermiculite contained some asbestos when it was originally mined.

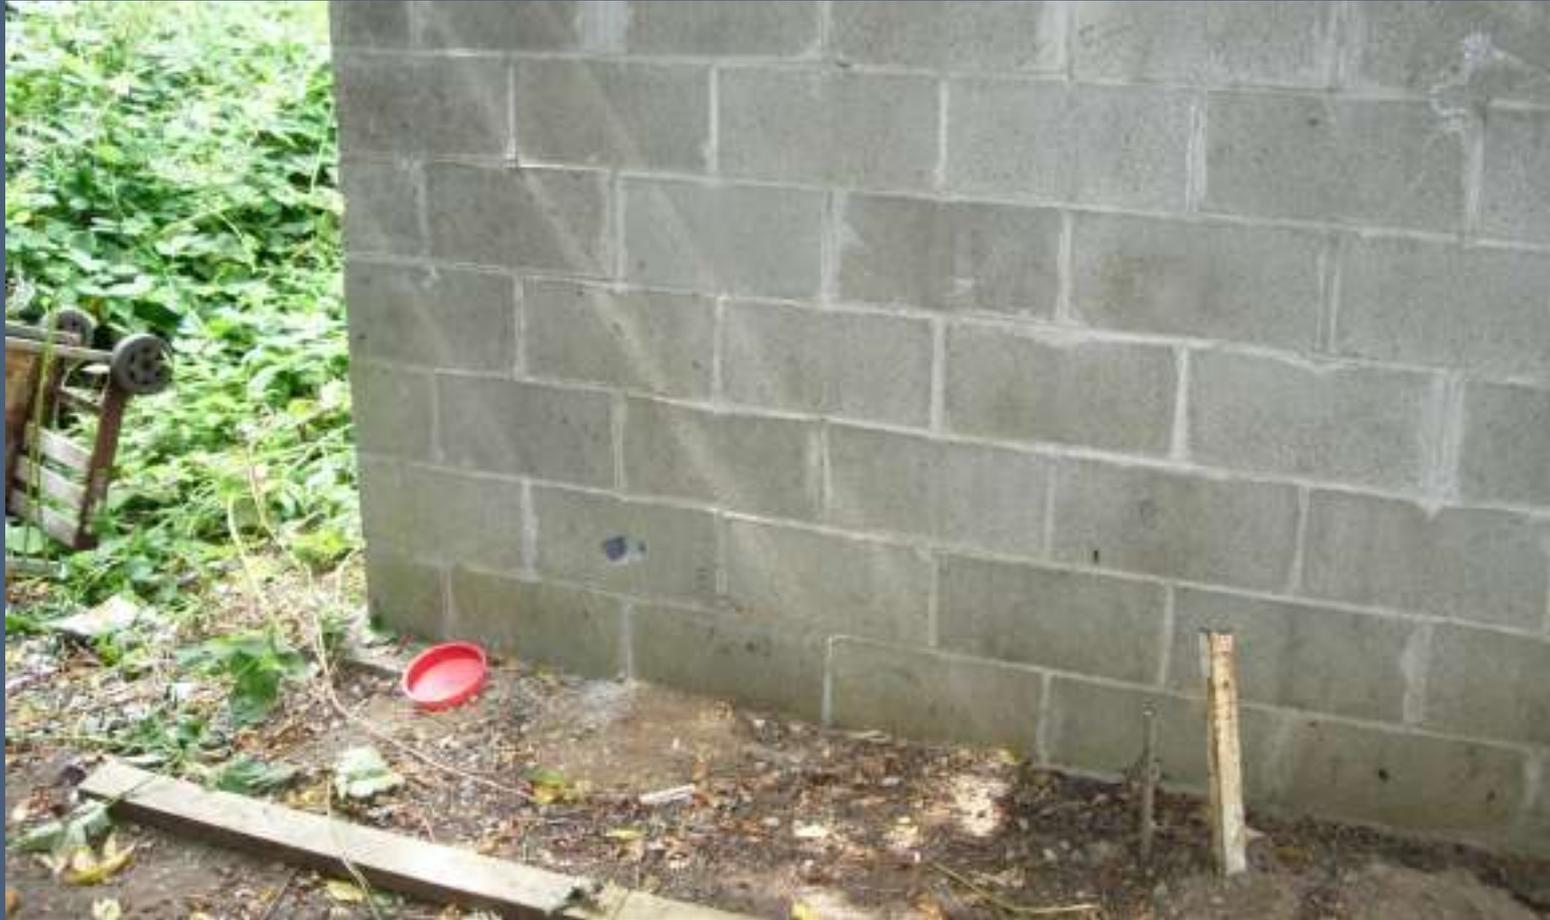
- Concrete block wall (CMU) insulation
- Fire separations
- Stove pipe insulation
- Cold rooms and refrigerators
- Attic insulation

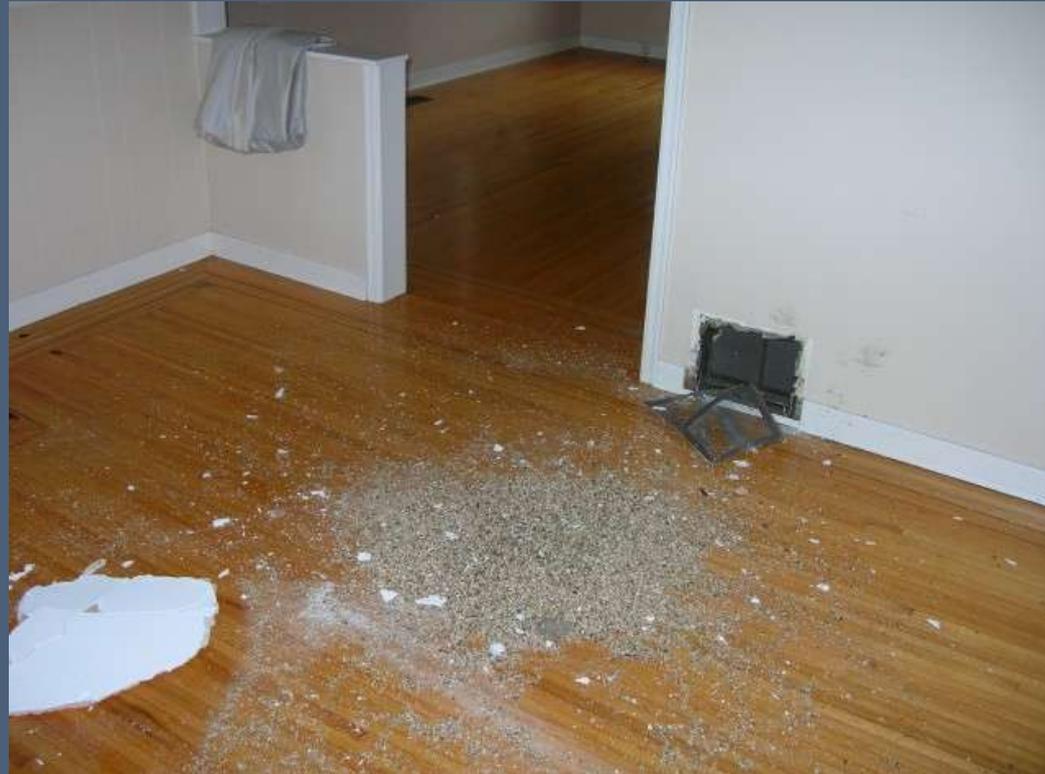
A demolition worker was exposed to asbestos when he punched a hole in the ceiling of a house and was “showered” with vermiculite insulation from the attic. The worker was not wearing a respirator. The vermiculite insulation contained 1 to 3 percent asbestos that was not identified when the home was originally tested for asbestos.
