# ALTERNATIVE SOLUTION

## William Griffin Community Recreation Center

# Mass Timber 'Spine'

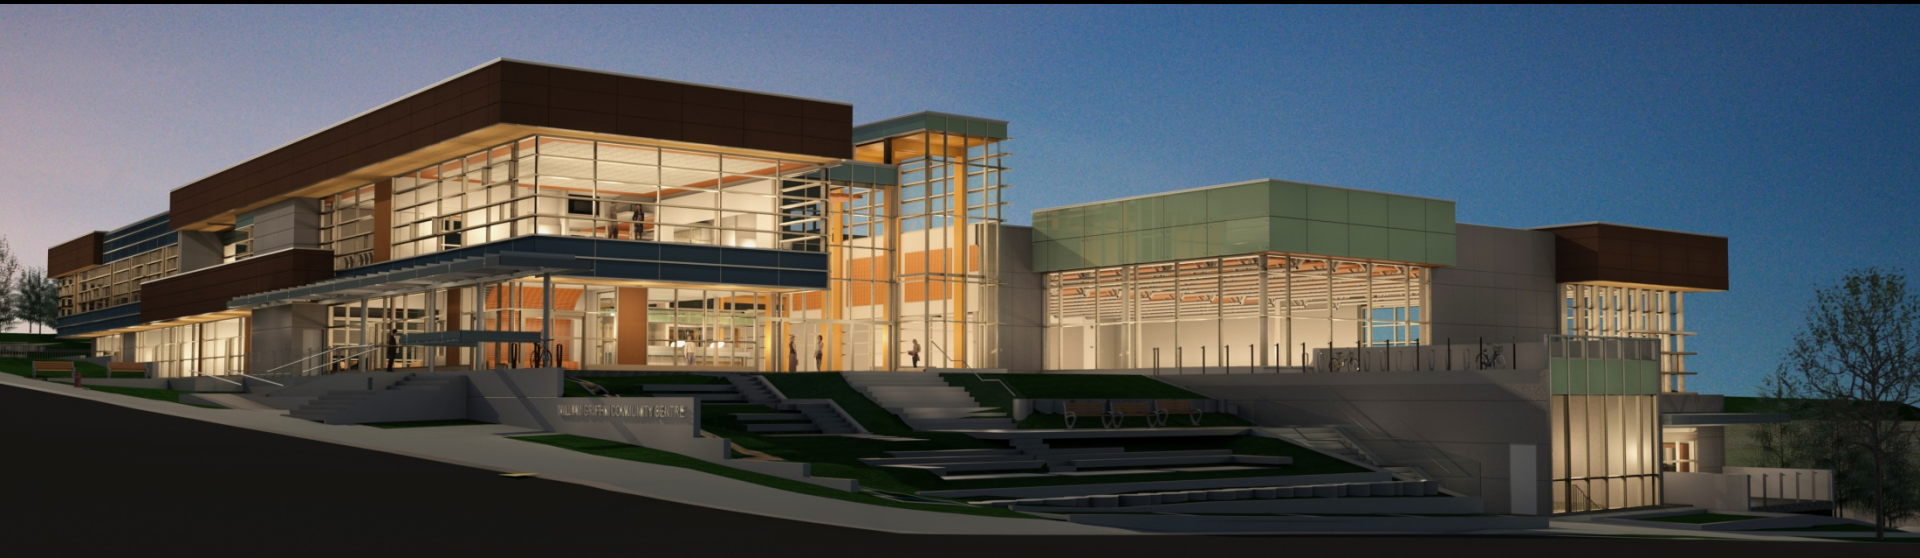
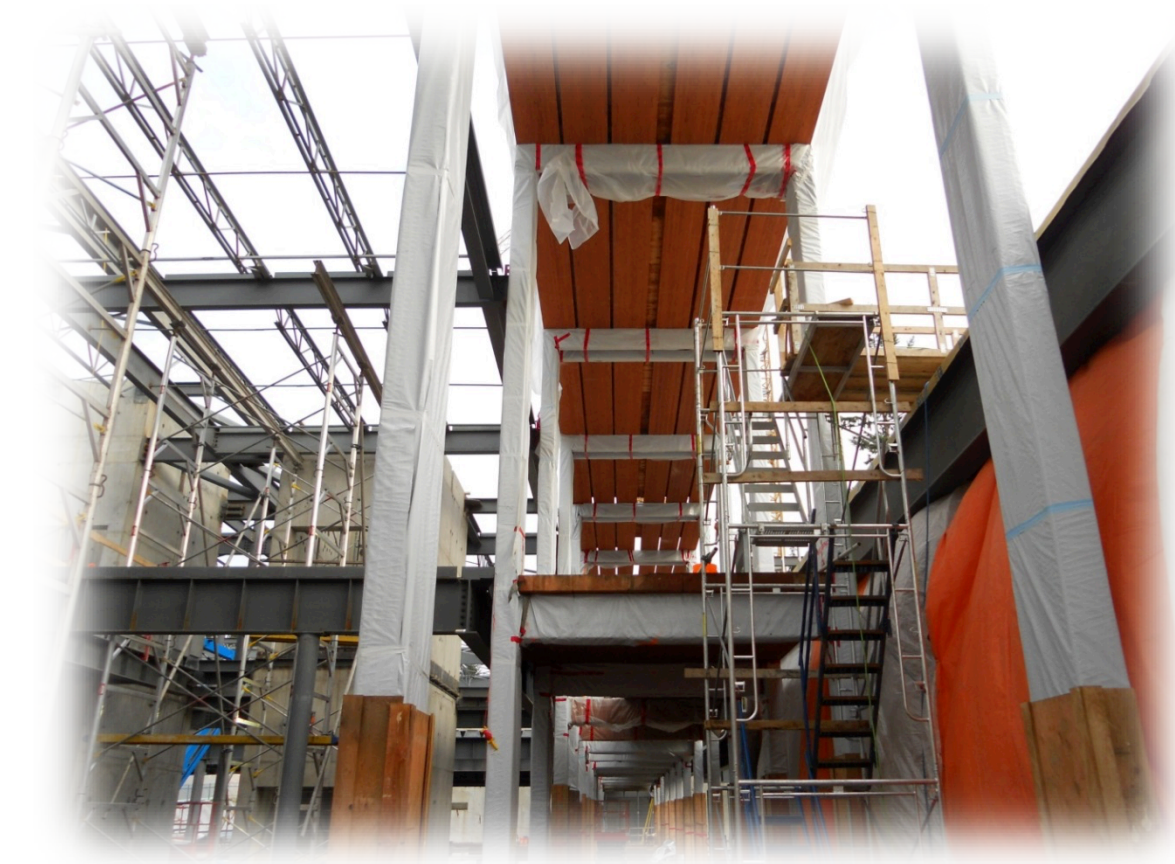
## 2 Storey “Timber Spine” (Upper level and Roof)

- 265x608 Glulam columns @  
5m O.C

### Upper Level

- 100mm conc topping on  
175mm thk GLT Panels
- 265x494 Glulam beams

### Roof Level

- 136mm thk GLT Panels
- 2-130x380 Glulam beams

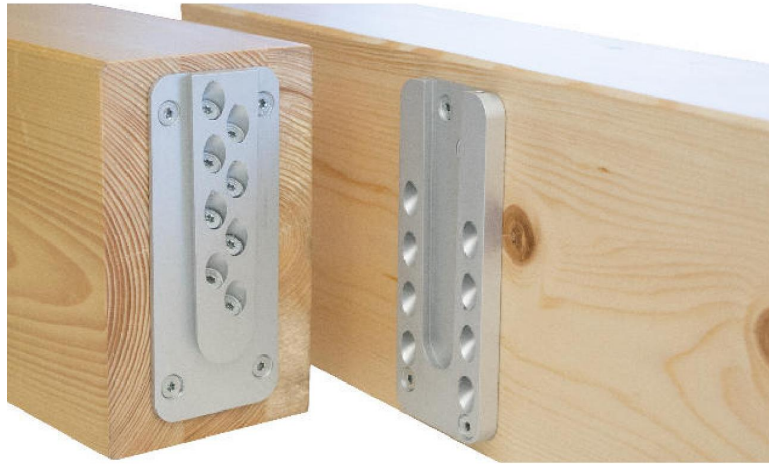
- “Pitzl” connector used with combination screws @ 45 & 90 deg
- Housing fully dapped into end of beam
- Protection on x 3 sides
- Design accounts for loss of screws after 1hr
- Clean, simple, fast.....and architect liked it
