BC BUILDING CODE INTERPRETATION COMMITTEE AIBC, APEGBC, BOABC, POABC

File No: 06-0014B INTERPRETATION Page 1 of 4

Interpretation Date:	April 15, 2008
Building Code Edition:	BC Building Code 2006
Subject:	Continuity of equivalent vertical fire separation through floor assembly horizontal service / concealed spaces
Keywords:	Floor assembly, horizontal service / concealed space, equivalent fire separation continuity, concealed space fire block, combustible construction
Building Code Reference(s):	3.1.8.3, 3.1.11.5, 3.1.11.7

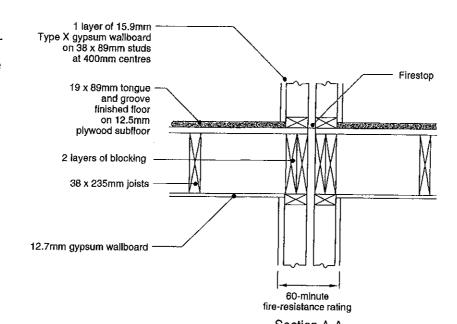
FIGURE 5.18

Continuity of fire separations

Note: The two layers of blocking are required when joists are parallel perpendicular to the wall.
